Report No. CETHA-BC-CR-89049

**Task Order 2
Enhanced Preliminary Assessment**

**DEFENSE MAPPING AGENCY (DMA)
HERNDON, VIRGINIA**

December 1989

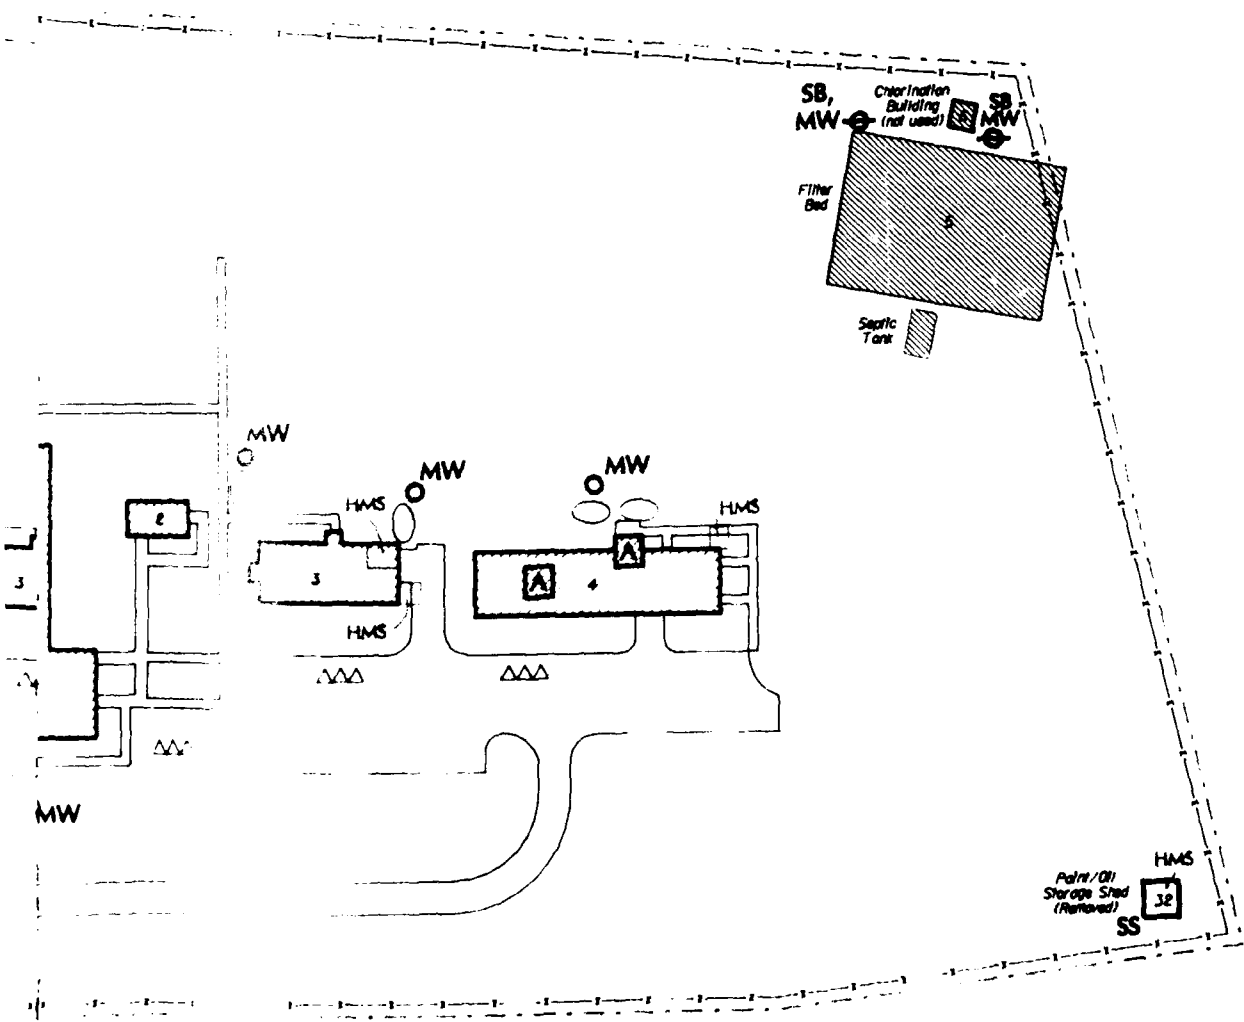
Figure ES-1
Property Information
Composite

- Underground Storage Tanks: Seven tanks, three active (used for storing gasoline and fuel oil) and four inactive (pumped out and filled with concrete). Two of the inactive tanks could not be successfully leak tested prior to being closed and may have released fuel oil to the surrounding soils and/or groundwater. Monitor wells have been installed near all tanks. No sampling has been conducted to date.

- Asbestos in Structures: Pipe insulation, floor tiles, and other materials in the four main buildings onsite have been tested and found to contain asbestos. Asbestos materials appear in good condition.

No environmental conditions were observed on the DMA property that appear to present an immediate substantial threat to human health or the environment. However, the ESOs discussed in Section 3 have the potential to affect human health or the environment. The recommendations concerning each item follow and are summarized in Table ES-1. Recommended sampling locations are shown in Figure ES-1.

The former paint/oil storage shed could have been a source for a release of hazardous materials to the environment. Surface soil samples should be taken in the area after the location of the shed has been determined.

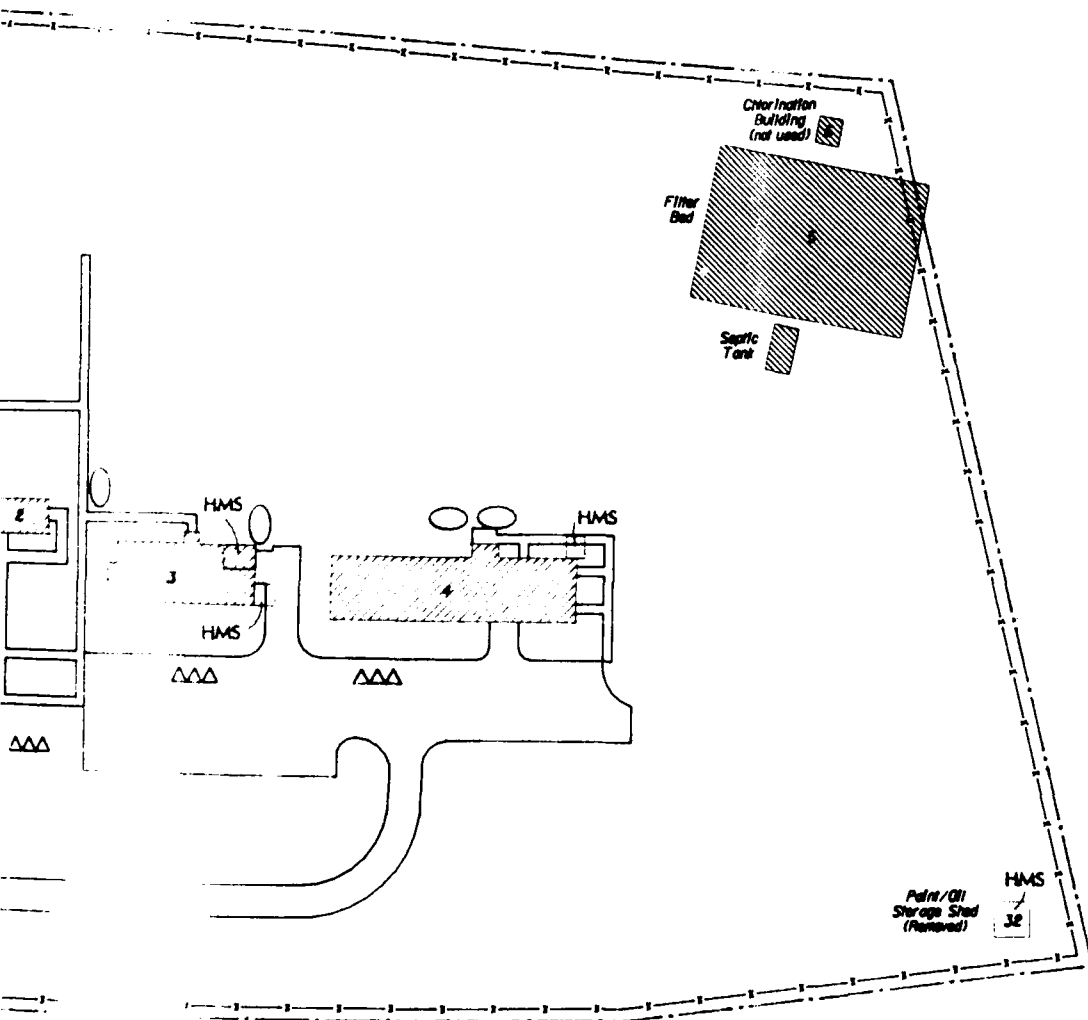
Figure 3-1
Environmentally Significant
Operations

The two tanks at Buildings 3 and 4 could not be effectively leak tested and there was some breakage or corrosion associated with the fill pipes. Accordingly, there is a possibility that underground storage tanks on the facility may have released some of their contents to soils.

^bNot tested due to 15 in. of water in the vessel. Report noted degraded condition of the tank fill pipe. In a site plan of the facility, the tank volume of 1,000 gal was identified.

^cThis is a second tank located approximately 21 ft west of the active tank behind Building 4. The tank was in poor condition at the time of the survey, and the fill pipe had separated from the tank. In a site plan of the facility, the tank volume of 1,000 gal was identified.
